School District  
of  
Reedsburg

# FACILITIES CONDITION ASSESSMENT REPORT

SCHOOL DISTRICT OF REEDSBURG  
Reedsburg, Wisconsin

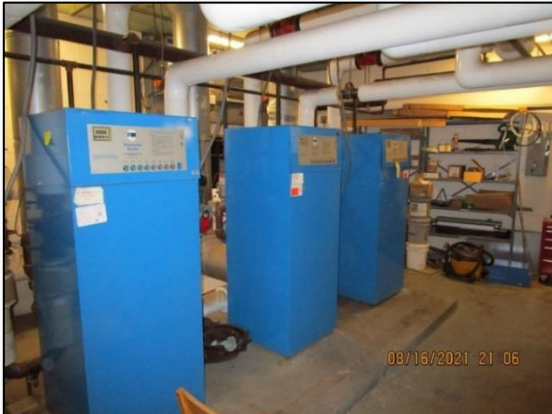
Three of the five Patterson-Kelly gas-fired 2,000,000 MMbtu hot water boilers circa 1998 are in good condition

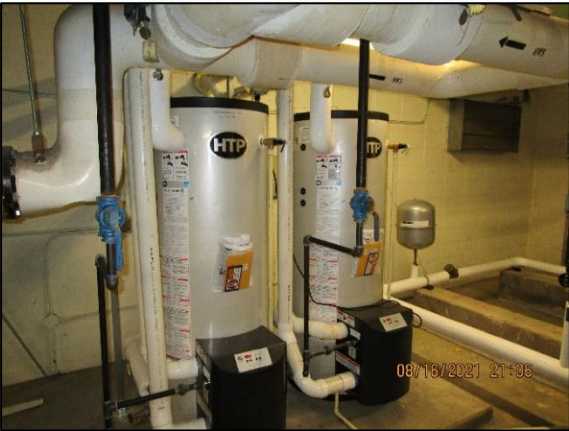
Brand new two 120-gallon gas-fired domestic hot water heaters installed February 2021

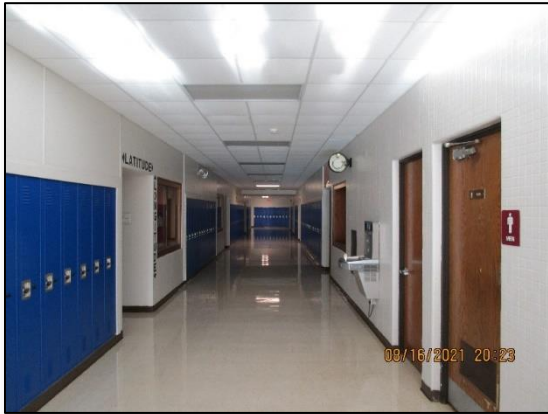
Corridors with CMU, corkboard, VCT and ACT are in good condition and well maintained

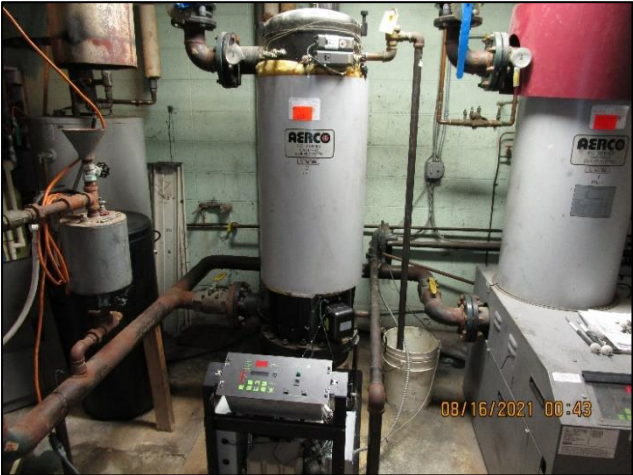
(1 of 2) Aerco hot water boilers are in good condition and well maintained. This one was in the process of being rebuilt

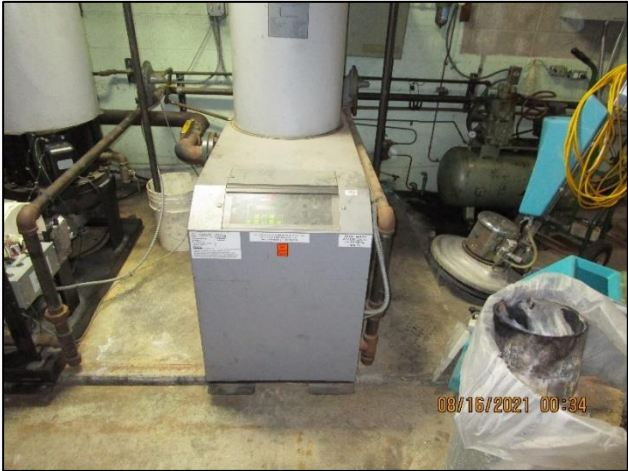
(2 of 2) Aerco hot water boilers are in good condition and well maintained.

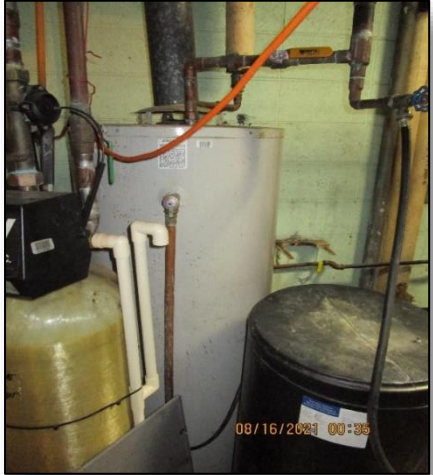
80-gallon gas-fired domestic hot water heater and water softener installed in 2018 in good condition

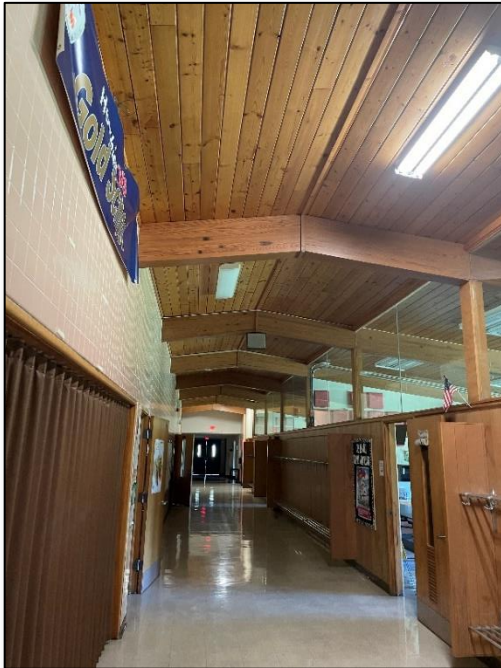
12" x 12" VCT on floors in corridors and classroom. 1 ¼" tongue and groove wood ceiling are in good condition

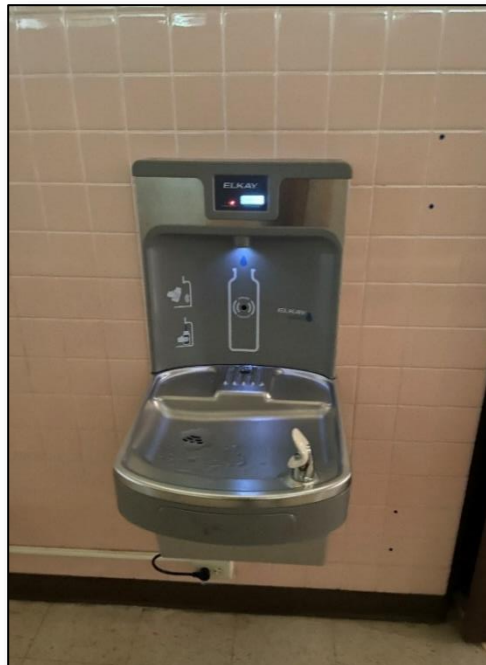
New energy saving water fountains installed in building

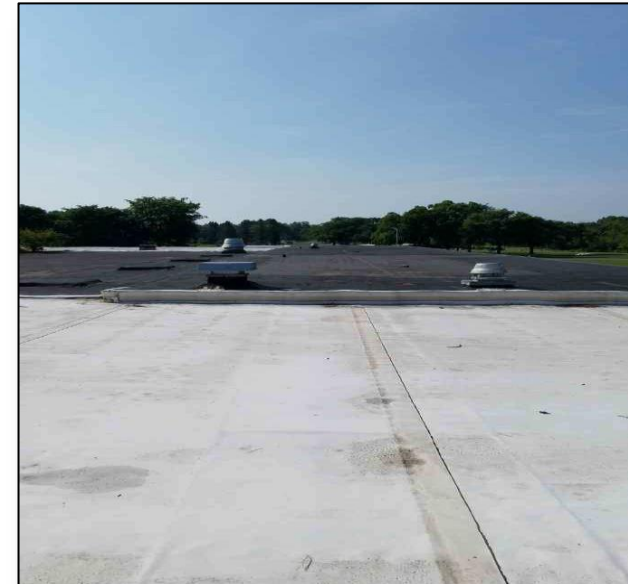
Roof is approximately 5 years old and in good condition

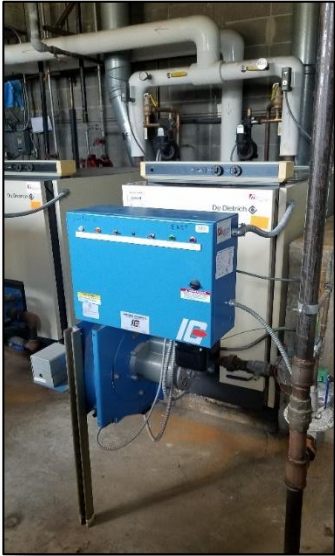
Boilers are in good condition and well maintained

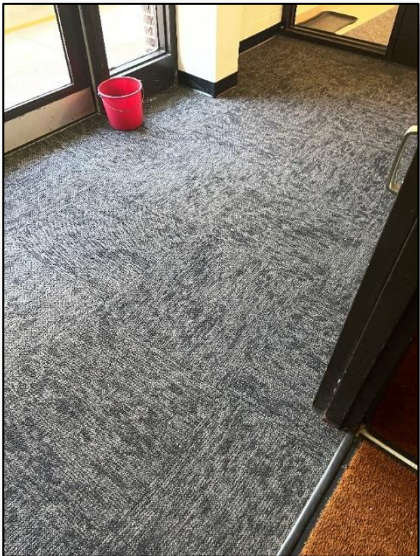
Newer carpet tiles at entrances in good condition

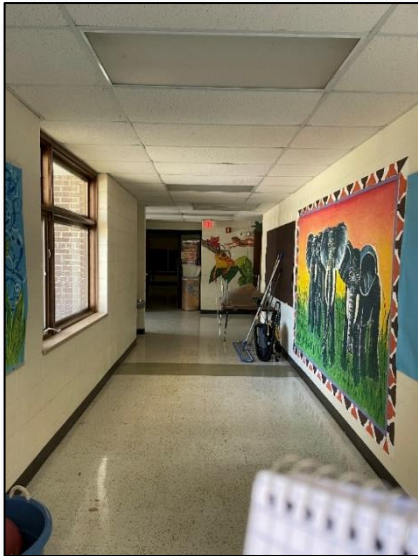
VCT and ACT in building are in good condition and well maintained

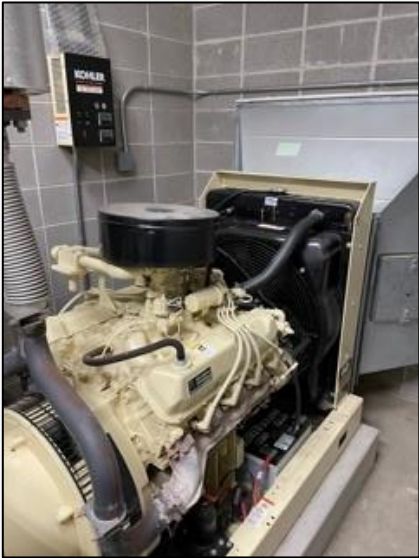
Building has an 80 kW generator in excellent condition

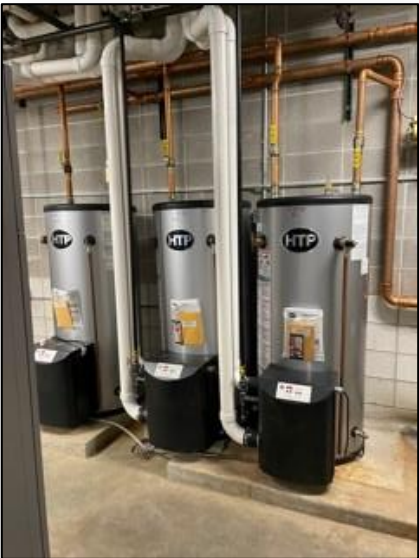
Three domestic HW Heaters in good condition

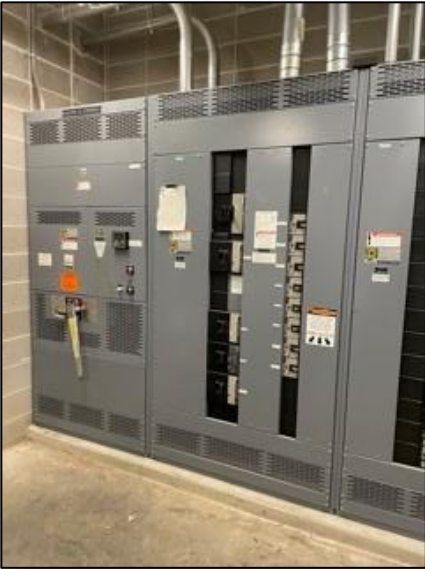
Building has a 3000 amp Main Distribution Panel, providing 480/277V to building

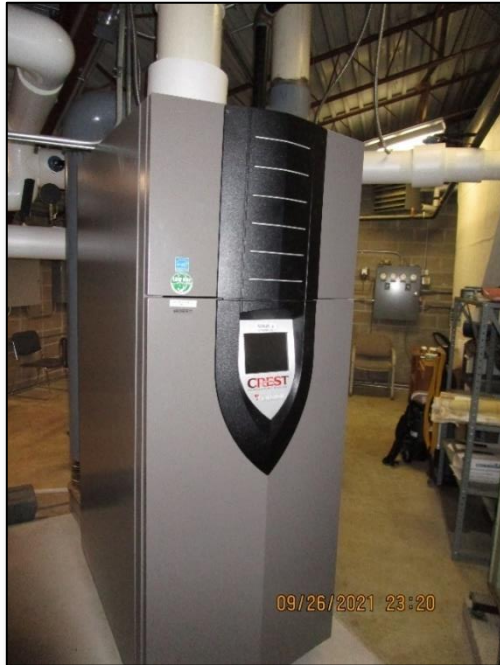
Newer Lochnivar boilers installed in 2018 are in good condition

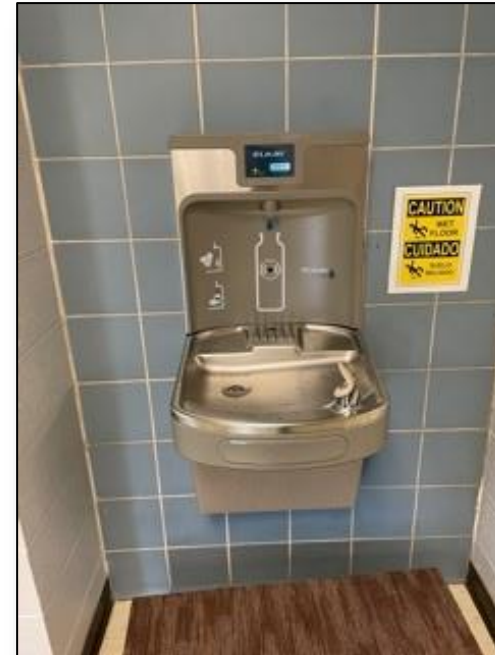
New energy efficient water fountains installed

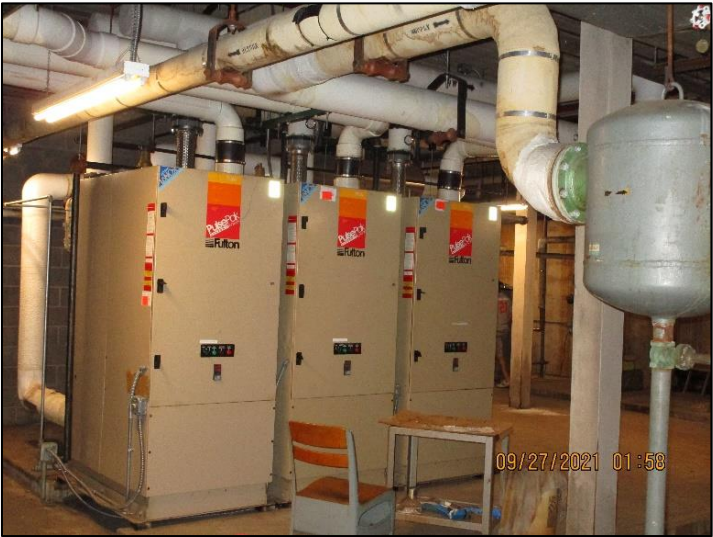
Three Fulton Boilers installed in 2004 are in good condition

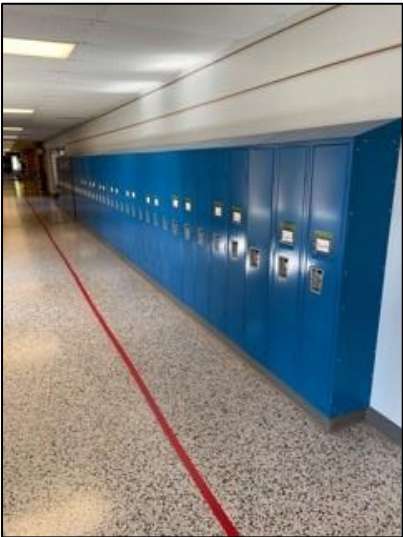
Terrazzo concrete floors are durable and in good condition

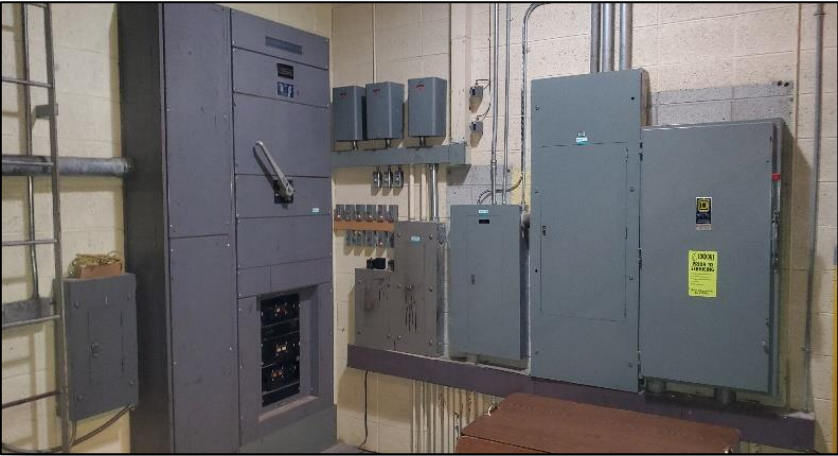
**Impact:** The existing electrical utility can fail and cause a system wide outage. No emergency generator and limited egress and exit signage throughout the building.

The existing aged incoming electrical main incoming switch and distribution panels behind gymnasium.

Save money and energy. Bulbs on LED lighting life expectancy is 10 years or possibly more in a school building. No loss of life in an event of an emergency.

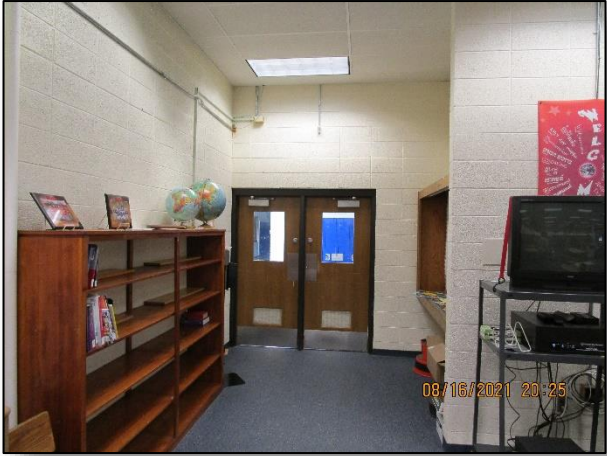
Library and other rooms limited egress and exit signage which would cause confusing during an emergency evacuation.
