School District  
of  
Reedsburg

# FACILITIES CONDITION ASSESSMENT REPORT

SCHOOL DISTRICT OF REEDSBURG  
Reedsburg, Wisconsin

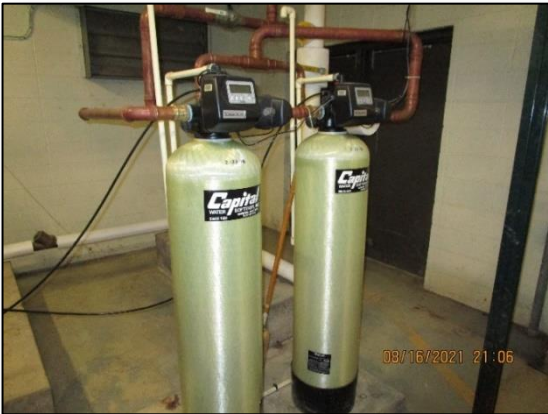
Duplex water softener installed in 2018 for boiler and domestic water

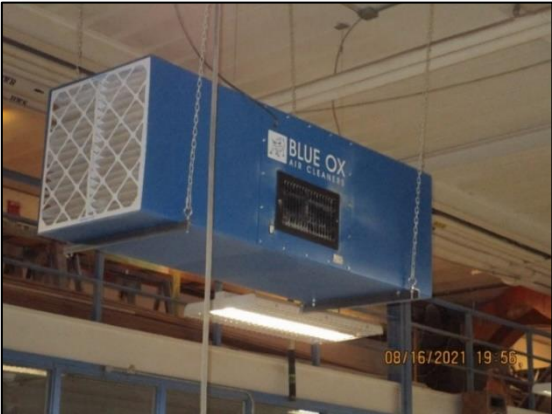
Wood Shop has 3 air scrubbers for dust control

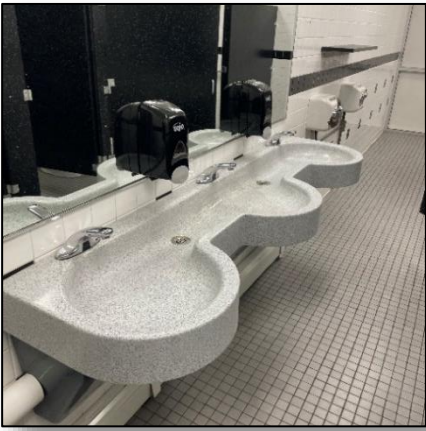
Newer sinks and fixtures with touch control in restrooms

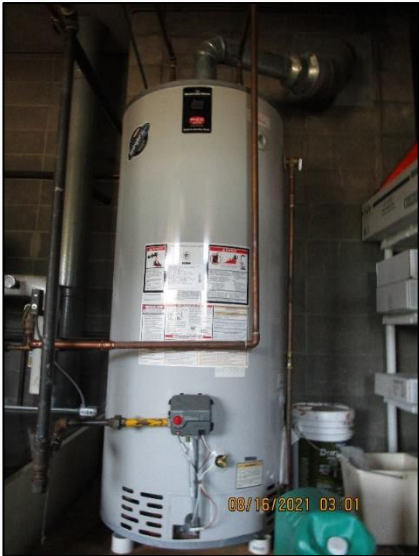
New energy saving water domestic hot water heater installed

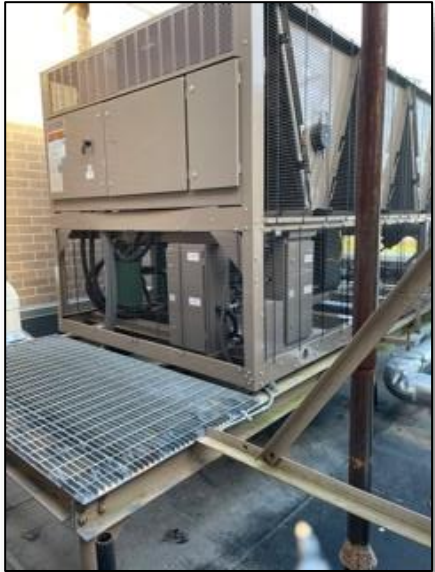
Building has 2 chillers installed in 2019 providing 250 tons of cooling throughout building

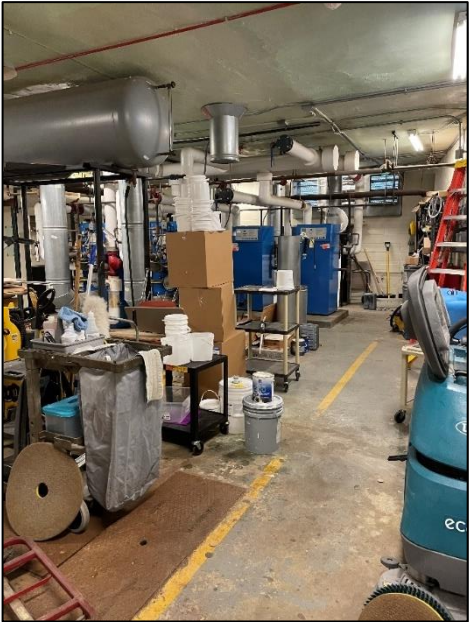
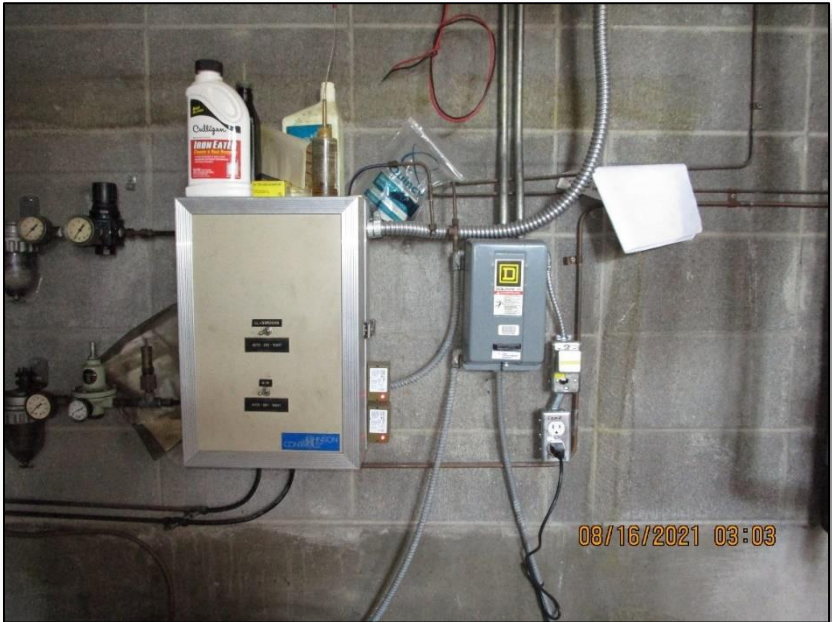
**Building could use some energy saving initiatives implemented such as automatic control system, VFDs installed on pumps, and outdoor reset on boilers. Mechanical rooms can use some housekeeping.**

Implementation of outdoor reset would heat water based on outdoor temperature and heat according, thus saving energy. Once building temperature is satisfied, the pumps would run at a lower percentage. Installation of automatic controls would provide the opportunity to control energy consumption and monitor equipment operation in real time.

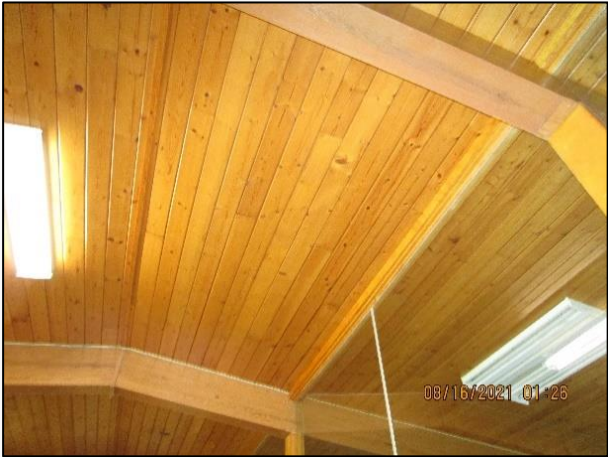
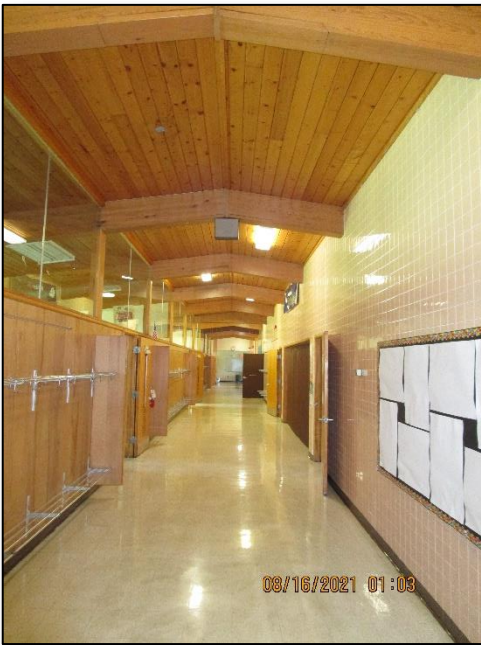
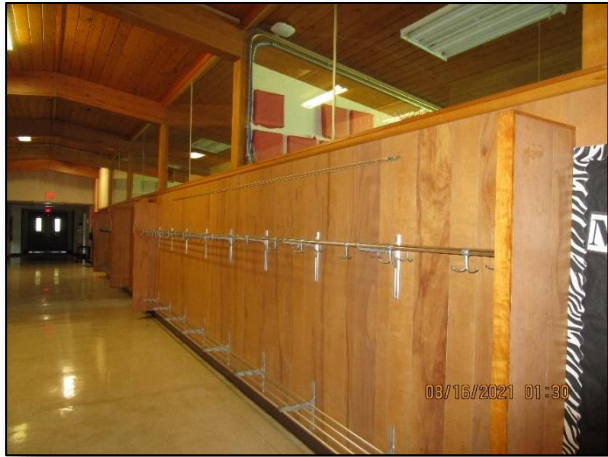
Library and other rooms limited egress and exit signage which would cause confusing during an emergency evacuation.

**Upgrade lighting to new LED for energy efficiency throughout building. Install additional egress lighting and exit signs; the egress lighting does not meet code compliance of one foot candle per square foot.**

Save money and energy. Bulbs on LED lighting life expectancy is 10 years or possibly more in a school building. No loss of life in an event of an emergency.

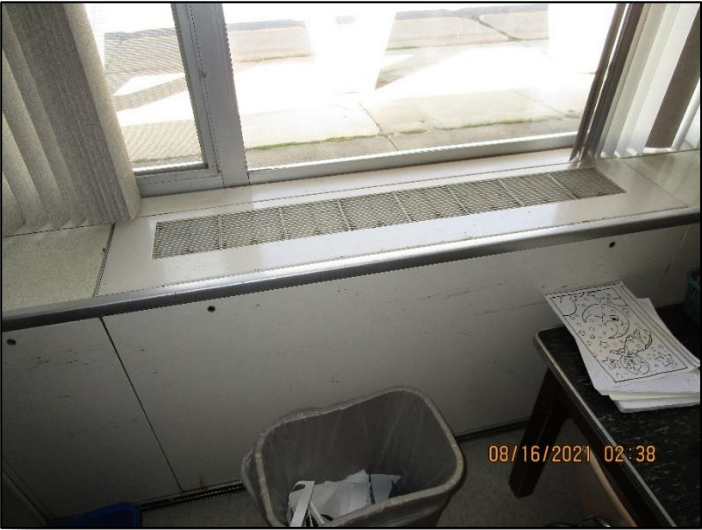
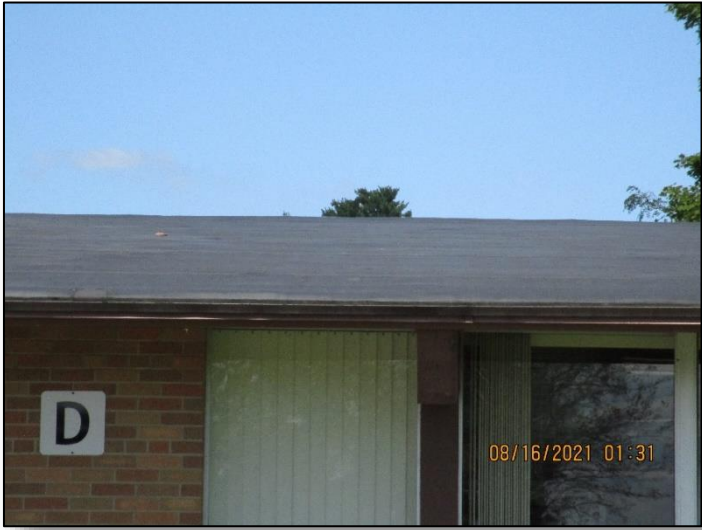
LOGANVILLE ELEMENTARY SCHOOL

**Curtain walls could use low E-glass windows with R value of 19 for the exterior walls.**

This will provide energy saving and occupant comfort level.

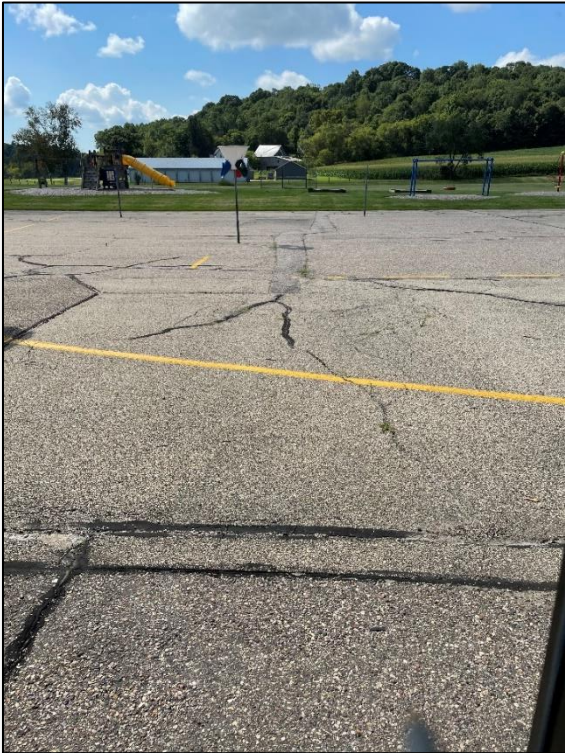
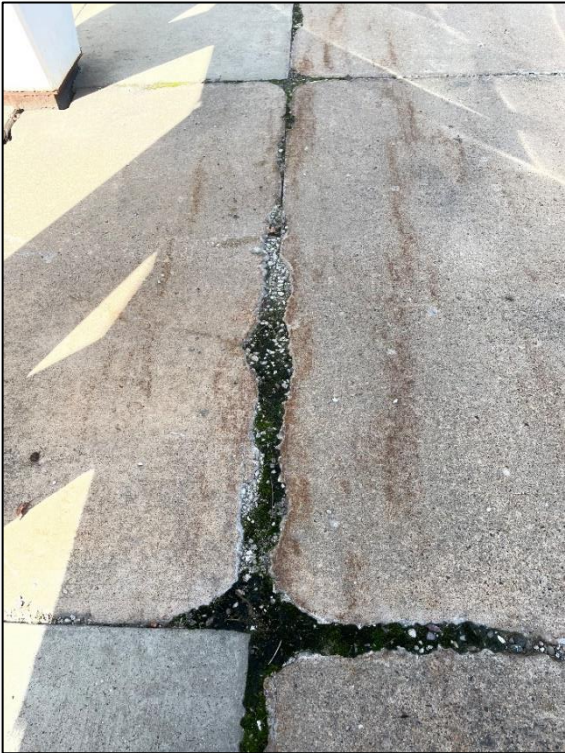
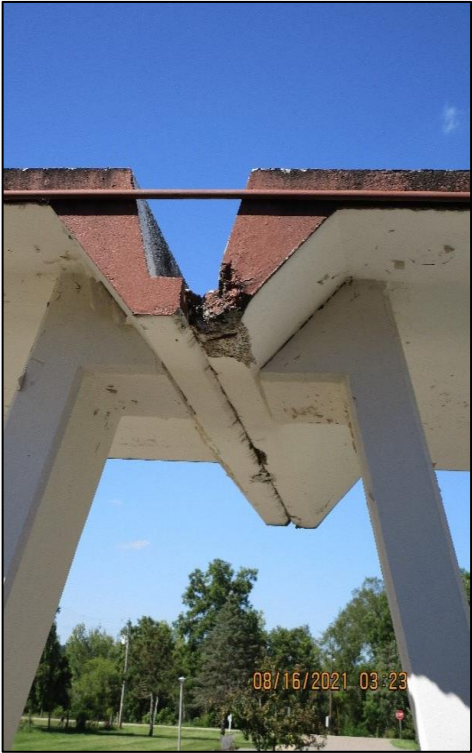
## IRONTON-LAVALLE ELEMENTARY SCHOOL

Asphalt on playground at the rear of building needs to be resurfaced, concrete pavers in front of building are deteriorated, and exterior canopy is structurally failing at front of building.

These items need to be addressed for the safety of the students and staff.

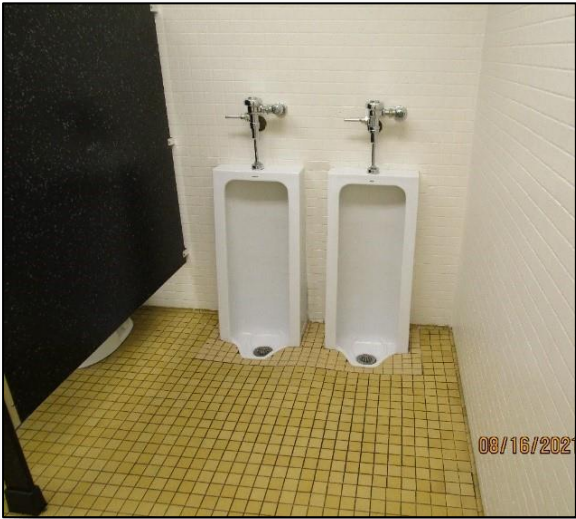
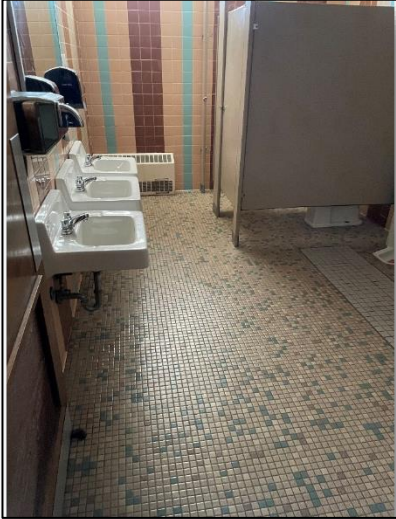
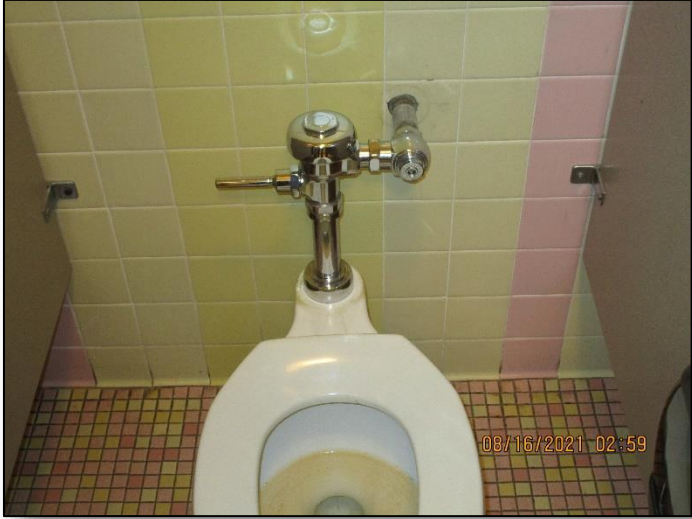
## IRONTON-LAVALLE ELEMENTARY SCHOOL CONTINUED

**Bathrooms should be updated. Floor-mounted urinals with grout lines are hard to clean and cause an unsanitary condition. Sinks and toilets are outdated and should be replaced with touch-free controls.**

Upgrading the bathrooms will eliminate the excessive amount of water usage. Also, it will provide a more sanitary environment for students and staff with touch-free controls.

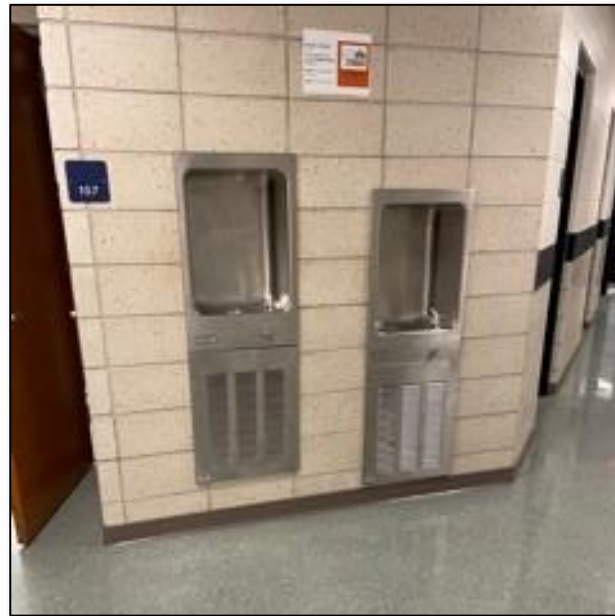
## REEDSBURG AREA HIGH SCHOOL

**Water fountains should be replaced with an energy efficient type as seen in elementary schools.**

This will provide energy saving and occupant comfort level.

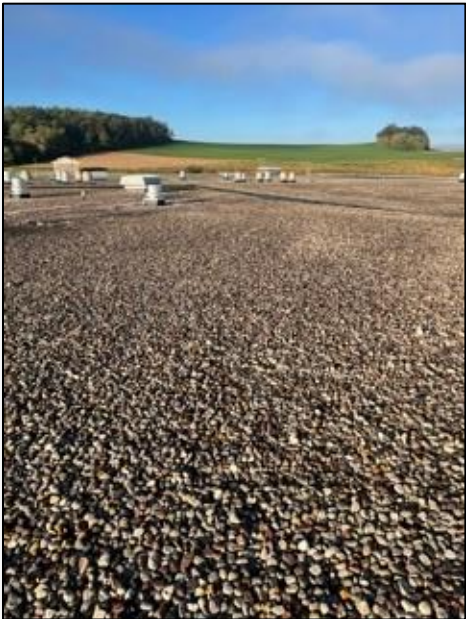
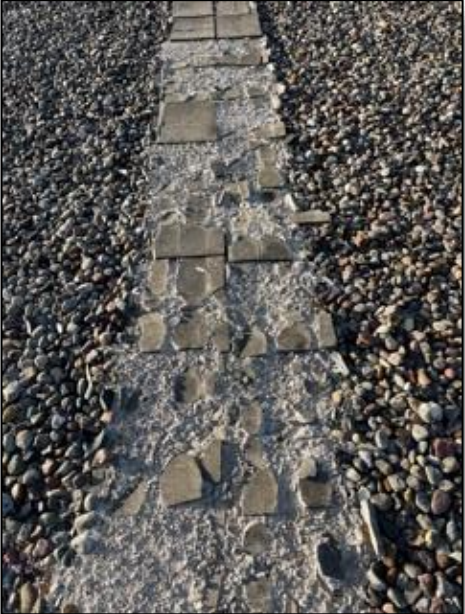
REEDSBURG ELEMENTARY SCHOOL – CONTNUED

**Bituminous built-up roof with gravel has leaks and should be repaired. Walkways on roof have deteriorated and may cause trip hazards.**

Repair roof to prevent widespread damage to building. Repair deteriorated walkways to prevent trip hazard.

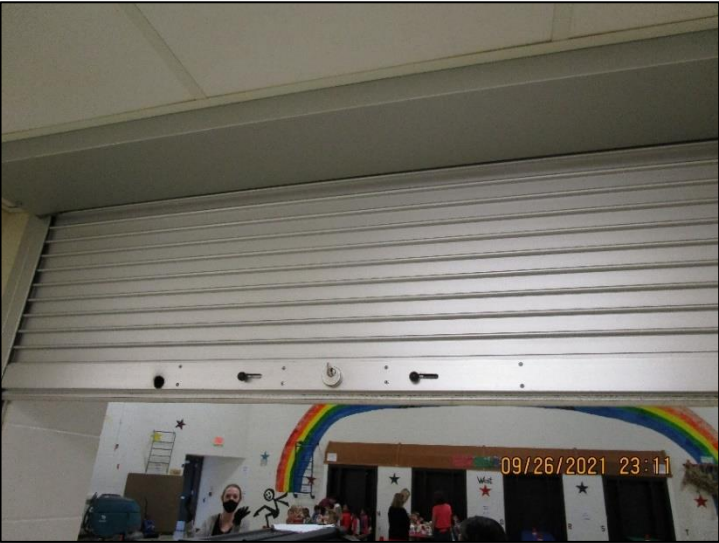
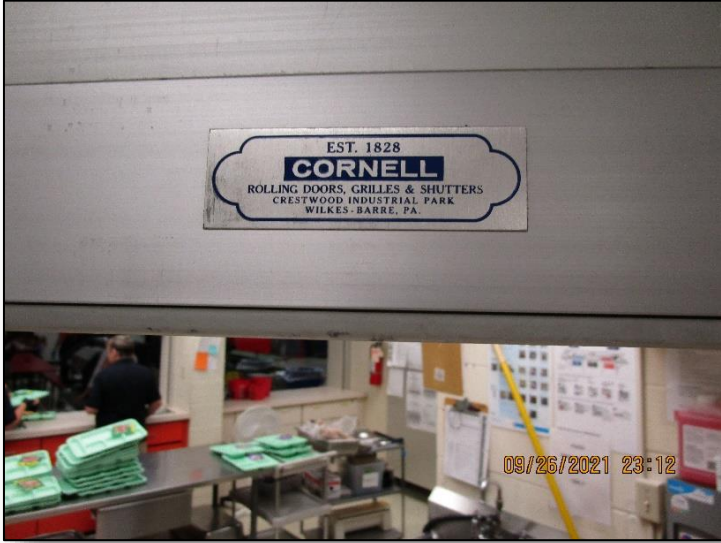
WESTSIDE ELEMENTARY SCHOOL

Rolling doors to cafeteria should be attached to a fire link in the event of a fire.

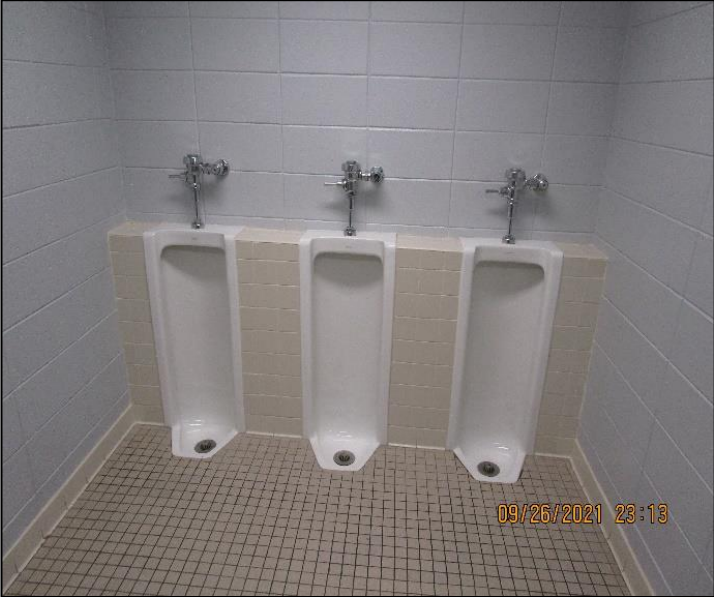
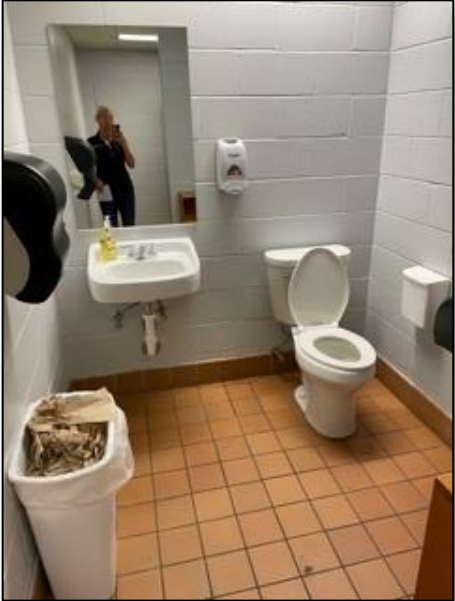
## WESTSIDE ELEMENTARY SCHOOL – CONTINUED

**Bathrooms should be updated. Floor-mounted urinals with grout lines are hard to clean and cause an unsanitary condition. Sinks and toilets are outdated and should be replaced with touch-free controls.**

Upgrading the bathrooms will eliminate the excessive amount of water usage and provide a more sanitary environment for students and staff with touch-free controls.

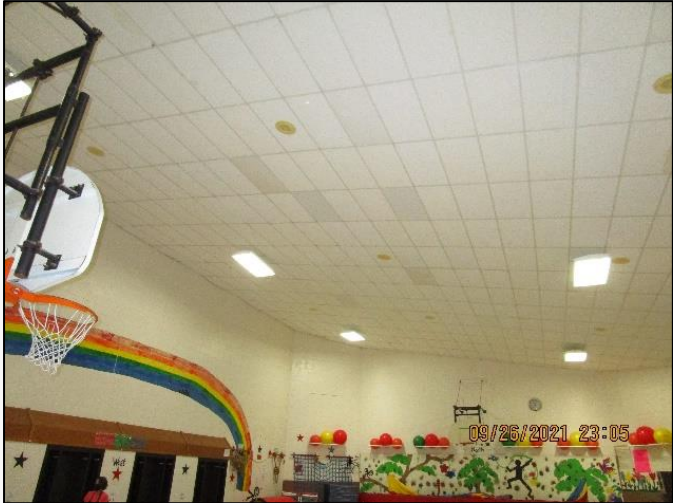
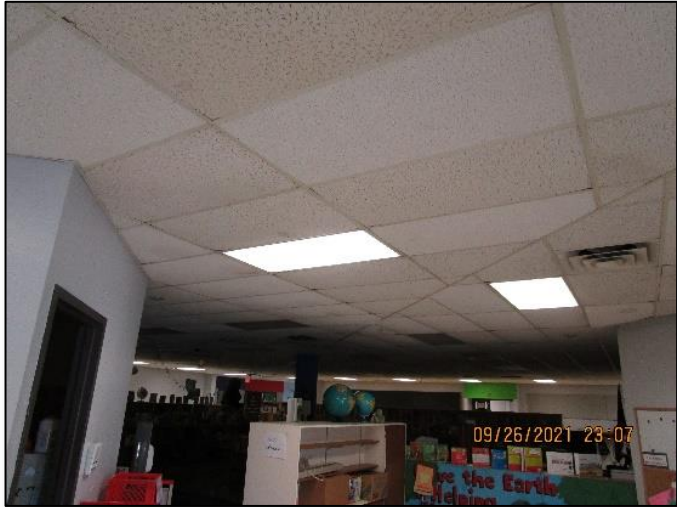
## WESTSIDE ELEMENTARY SCHOOL – CONTINUED

**Upgrade lighting to new LED for energy efficiency throughout building. Install additional egress lighting and exit signs; the egress lighting does not meet code compliance of one foot candle per square foot.**

Save money and energy. Bulbs on LED lighting life expectancy is 10 years or possibly more in a school building. No loss of life in an event of an emergency.

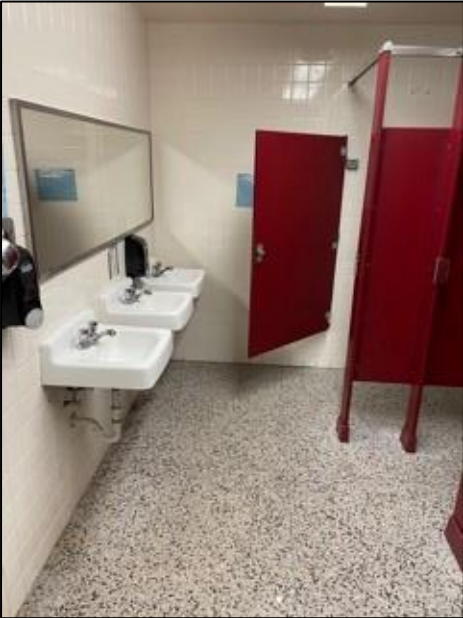
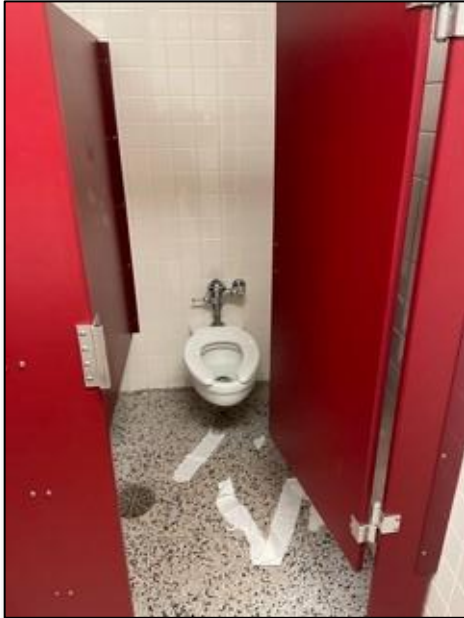
## PINEVIEW ELEMENTARY SCHOOL

**Bathrooms should be updated. Floor-mounted urinals with grout lines are hard to clean and cause an unsanitary condition. Sinks and toilets are outdated and should be replaced with touch-free controls.**

Upgrading the bathrooms will eliminate the excessive amount of water usage and provide a more sanitary environment for students and staff with touch-free controls.

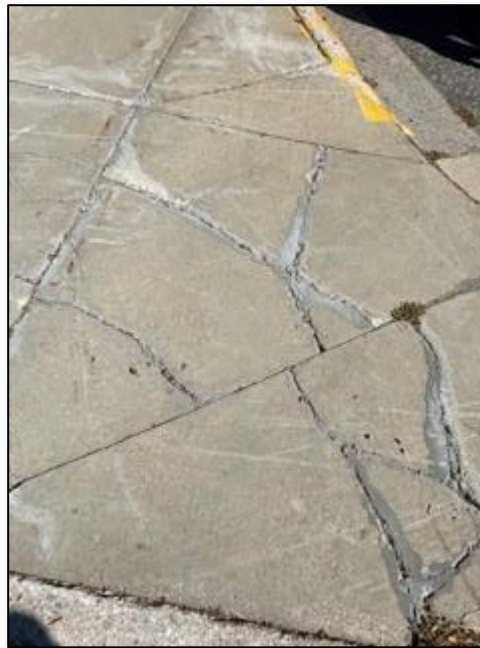
## PINEVIEW ELEMENTARY SCHOOL – CONTINUED

**Concrete pavers on walkway and handicapped ramp in front of building are deteriorated and may cause a trip hazard.**

These items need to be addressed for the safety of the students and staff.
